Manhole Inspection Summary

Manhole # S47EE_011MH

Insp Date: **7/17/08 9:12 AM**

Location Address: **Port**

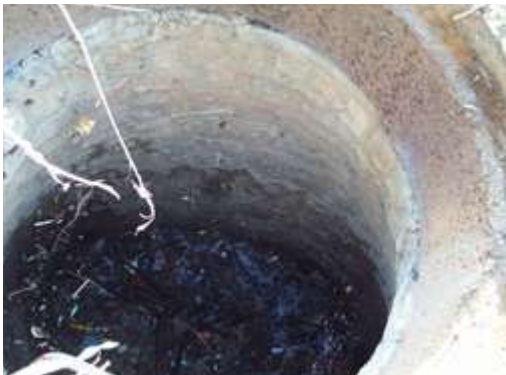
Defect 2

Frame Offset: **0.5** (in.) Condition: ☐ Sound ☐ Cracked ☒ **Leaks**

Frame leaks

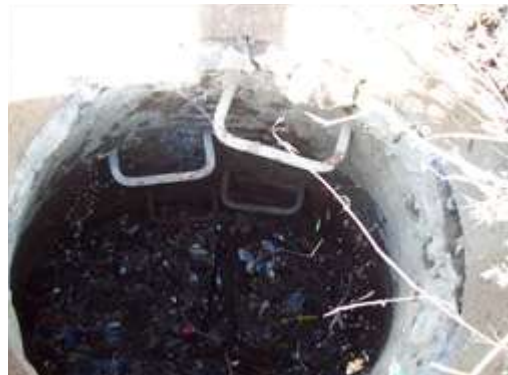
Defect 1

Infiltration: ☐ None ☒ **Joint** ☐ Cracks ☒ **Mortar** ☐ Roots ☐ Wall

Infiltration

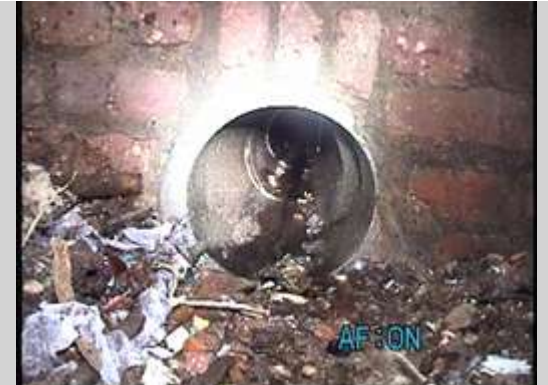
12 O'Clock Outflow

8 in. Circular Gravity Sewer
Pipe Out @ 12 O'Clock

Infiltration: **None** Pipe Seal Cond: **Sound**
